## TEST REPORT

No. : SC100620597

Sample Name : Shoring tower  
Sample Number : SC100620597  
Test Required : Load capacity  
Test Method : SGS in house  
Product specification : ST 60  
Date of Receipt : Jun. 30, 2014  
Test Period : Jun. 30, 2014 to July. 02, 2014  
Test result(s) : For further details, please refer to the following page(s)

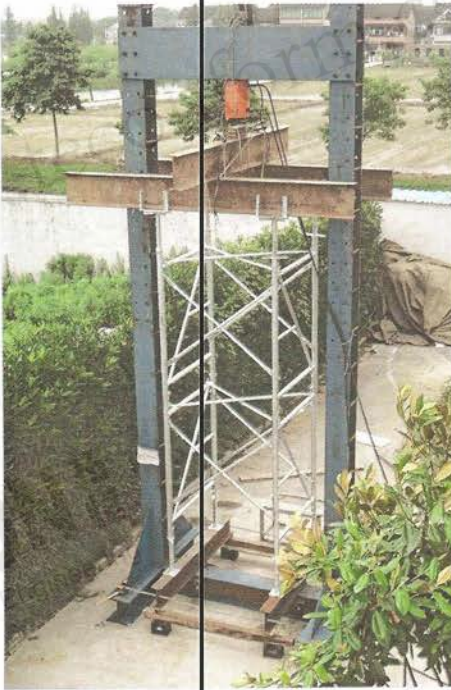
Before test

1. Install the scaffold in accordance with manufacturer's indication.
2. Apply a steadily increasing load to the four support pillars until failure of any part of the scaffold occurs or the load can not be increased availablely.
3. Record the maximum load and the failure status.

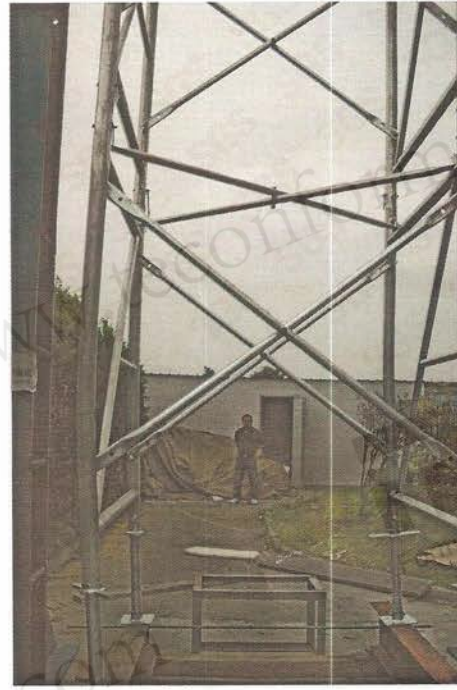
Test item	Test result	Description
Load capacity (four supports total load)	$F_{max} = 857kN$	The support pillar showed permanent distortion.

After test
